March 30, 2017

MKM File # 170161

Re: Muir Beach Community Building  
19 Seacape Drive  
Muir Beach, CA

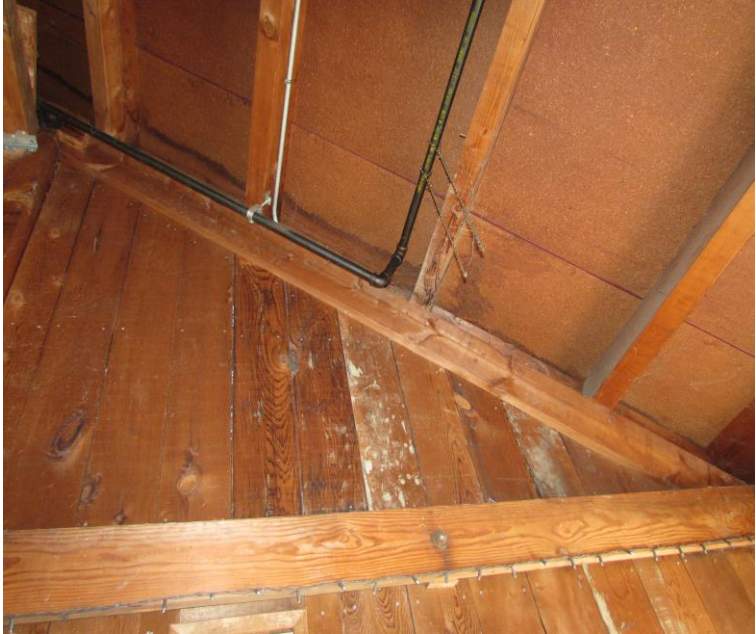
12. On the east gable end wall near the fireplace there are indications of an active roof leak. We suggest that the water intrusion be repaired and the water damaged wood framing be repaired/replaced. (see picture 1)

ITEM	OBSERVATIONS / COMMENTS	PHOTOS
1.	On the east gable end wall near the fireplace there are indications of an active roof leak. We suggest that the water intrusion be repaired and the water damaged wood framing be repaired/replaced.

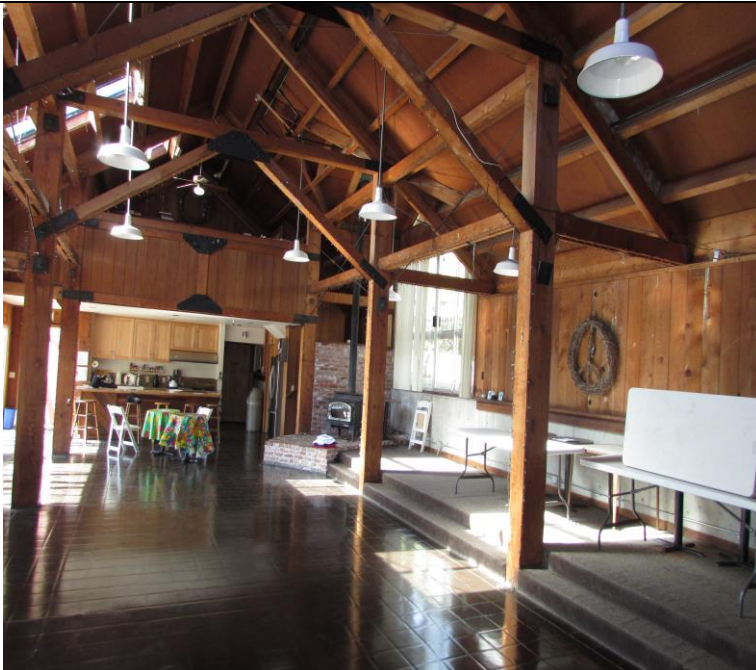
2. The lateral strength of the structure in the short direction depends on the heavy timber wood frames at 12 feet on center (see picture 2). The connections seem nominal and the wood post size (8x8) may be slightly undersized. We recommend strengthening these frames or adding additional wood shear walls.

2.	The structure consists of a series of heavy wood timber bolted frames at 12'-0" on center in the north/south or short direction within the main hall.

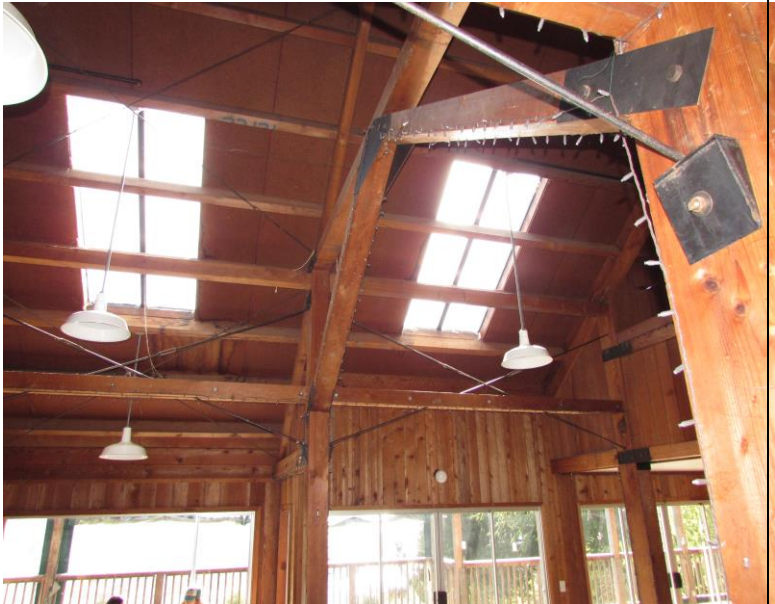
7. The steel rod cross bracing at the roof and between the steel frames appeared to be loose and sagging. We recommend that they be tightened (see picture 3).

ITEM	OBSERVATIONS / COMMENTS	PHOTOS
3.	The steel rod cross bracing at the roof and between the steel frames appeared to be loose and sagging. We recommend that they be tightened.

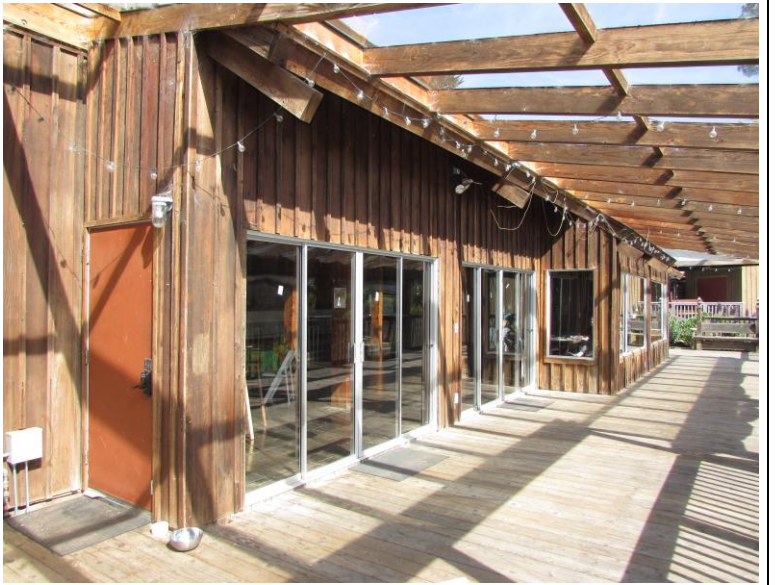
15. The trellis over the south facing deck appears to be marginally supported vertically and laterally at the roof of the building. An improved connection should be developed at the existing roof interface. Possible replacement of the existing framing may be recommended to accommodate an adequate connection (see picture 4).

16. A portion of the trellis framing appears to be supported by the existing roof framing and cantilevered floor framing. We recommend that the existing roof framing support be strengthened to properly support the trellis roof and glazing (see picture 4).

4.	The trellis over the south facing deck appears to be marginally supported vertically and laterally at the roof of the building. An improved connection should be developed at the existing roof interface. Possible replacement of the existing framing may be recommended to accommodate an adequate connection.

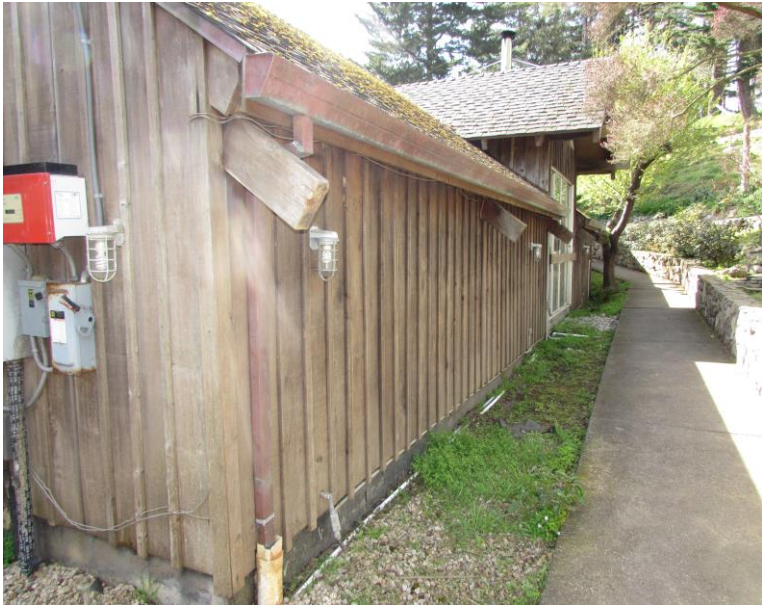
13. There is a moss build up on the roofing on the north side. We recommend that this be removed (see picture 5).
14. The ends and tops of the exposed cantilevered rafters that extend past the roof have indications of water damage. We recommend that these rafters be repaired and protected (see picture 5).

ITEM	OBSERVATIONS / COMMENTS	PHOTOS
5.	The ends and tops of the exposed cantilevered rafters that extend past the roof have indications of water damage. We recommend that these rafters be repaired and protected.

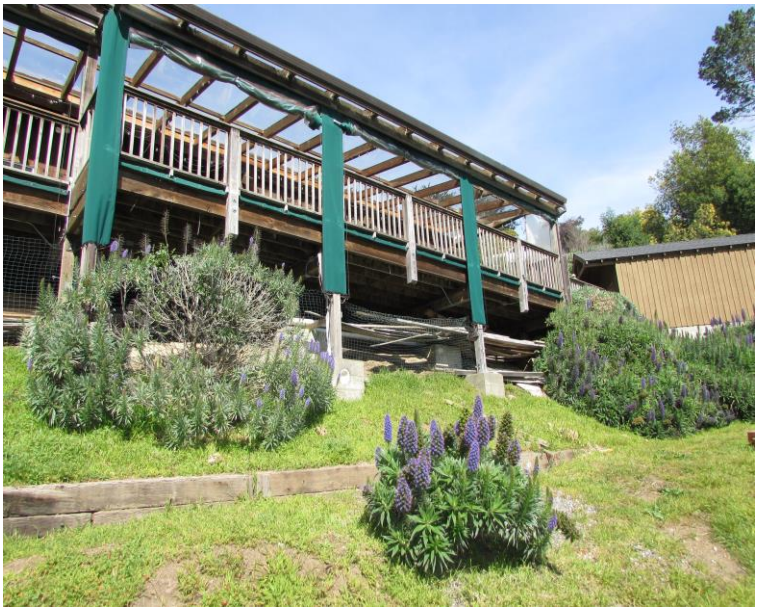
20. The deck framing is lacking some lateral bracing. We recommend that some cross bracing be installed to properly brace the deck for lateral loading as a result of seismic earth motion (see picture 6).

6.	The deck framing is lacking some lateral bracing. We recommend that some cross bracing be installed to properly brace the deck for lateral loading as a result of seismic earth motion.

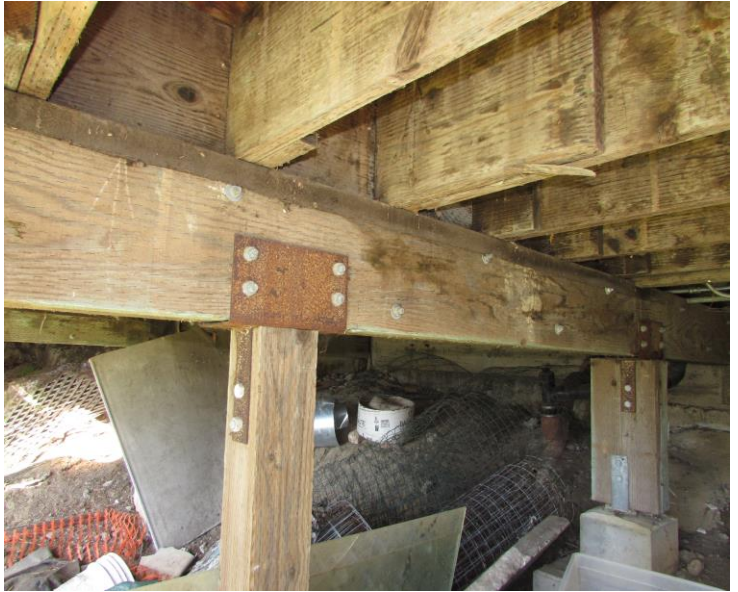
17. The exposed hardware at the exterior deck is rusting and we recommend replacement with stainless steel connections or at least epoxy painting the existing hardware (see picture 7).

ITEM	OBSERVATIONS / COMMENTS	PHOTOS
7.	The exposed hardware at the exterior deck is rusting and we recommend replacement with stainless steel connections or at least epoxy painting the existing hardware.

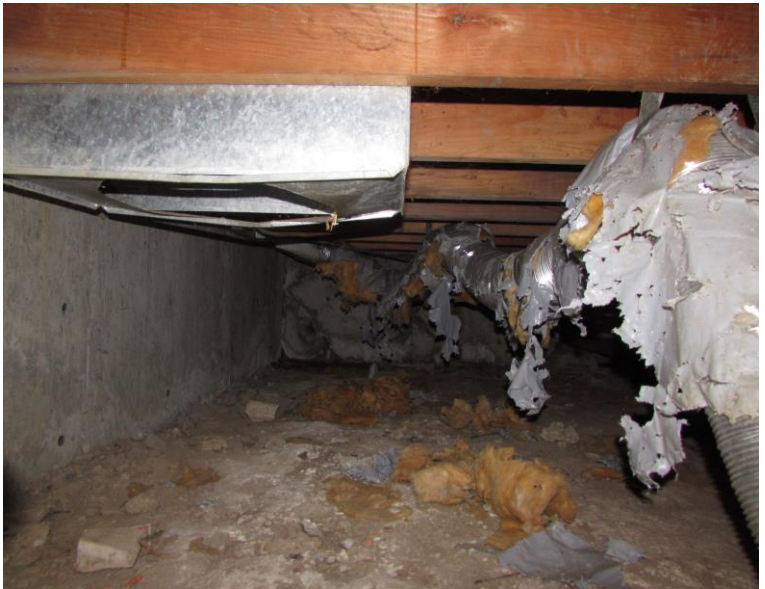
22. The mechanical flexible heating duct under the main floor has the outer cover and inner insulation ripped open. If the ducting is being used, we recommend that they should be replaced where the ducting has been compromised (see picture 8 and 12).

8.	The mechanical flexible heating duct under the main floor has the outer cover and inner insulation ripped open. If the ducting is being used, we recommend that they should be replaced where the ducting has been compromised.

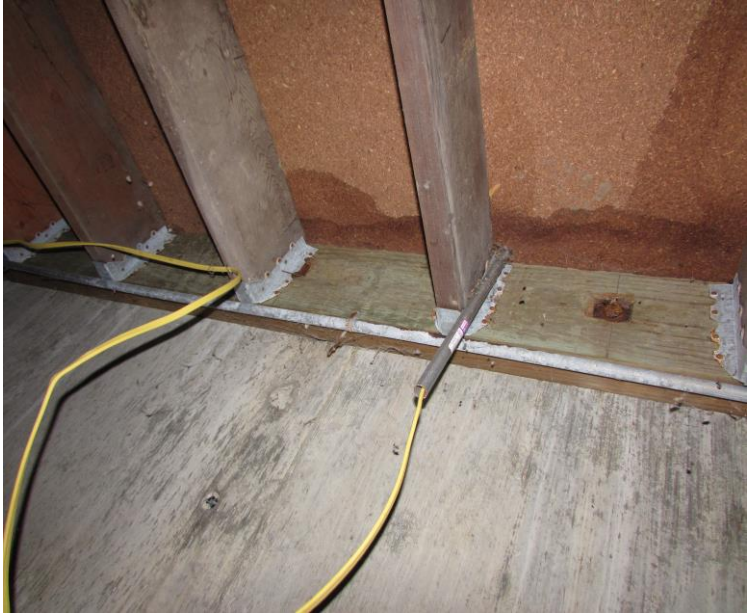
5. The main floor sheathing appears to be a particle board. We recommend replacement or adding plywood if you are doing any interior flooring work (see picture 9).

8. The large window on the front north elevation may be leaking. Water was noted on the wall, carpet, and the floor sheathing under the window was water stained (see picture 9).

ITEM	OBSERVATIONS / COMMENTS	PHOTOS
9.	<p>The large window on the front north elevation may be leaking. Water was noted on the wall, carpet, and the floor sheathing under the window was water stained.</p> <p>The main floor sheathing appears to be a particle board. We recommend replacement or adding plywood if you are doing any interior flooring work.</p>

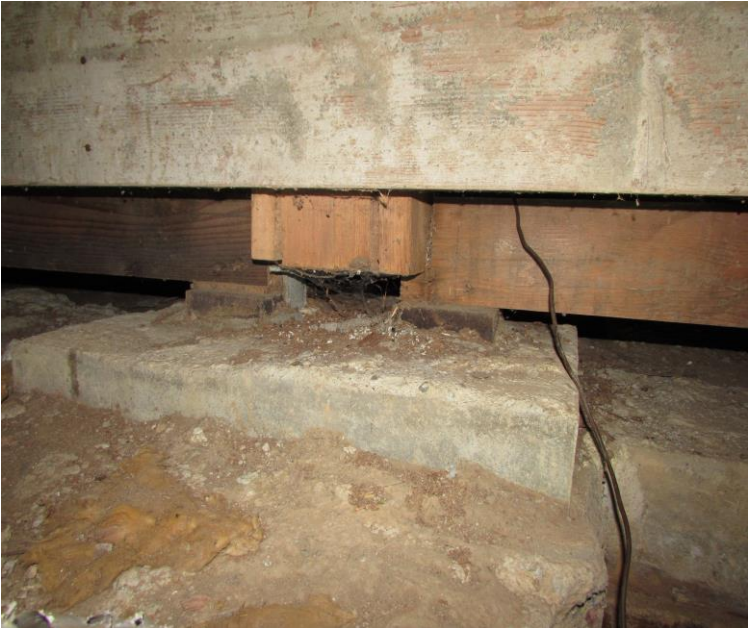
6. The interior posts for the wood timber frame are supported on steel post bases that are not supported directly to the top of the footing. We recommend adding non-expansive grout under the post bases (see picture 10).

10.	<p>The interior posts for the wood timber frame are supported on steel post bases that are not supported directly to the top of the footing. We recommend adding non-expansive grout under the post bases.</p>

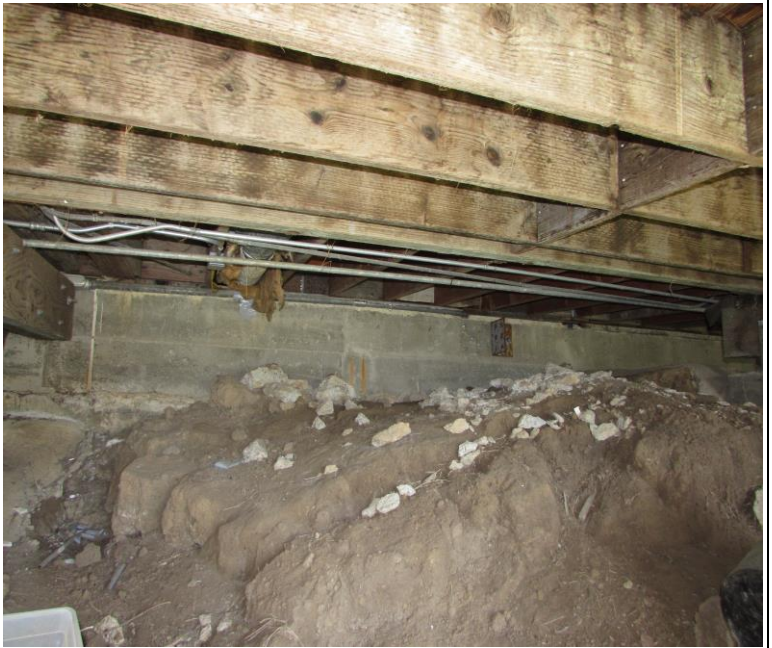
23. A mechanical duct has ripped insulation around the duct that is exposed under the exterior deck. This exterior ducting should be reviewed by a mechanical contractor and most likely be replaced or wrapped with insulation. In addition, these ducts should probably be enclosed (see picture 11).

ITEM	OBSERVATIONS / COMMENTS	PHOTOS
11.	A mechanical duct has ripped insulation around the duct that is exposed under the exterior deck. This exterior ducting should be reviewed by a mechanical contractor and most likely be replaced or wrapped with insulation. In addition, these ducts should probably be enclosed
